## Report of Findings

**Historical Property  
Structural Condition Assessment  
1005 West Third Street**

**Rimkus Matter No: 100145027**

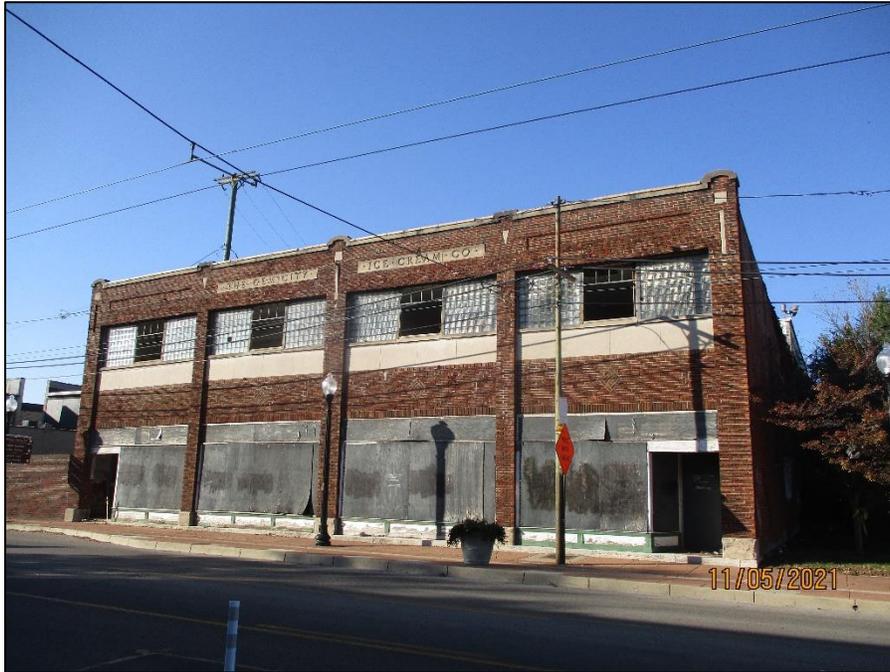
**Photograph 1**

South exterior façade at the front of the Gem Ice Cream building.

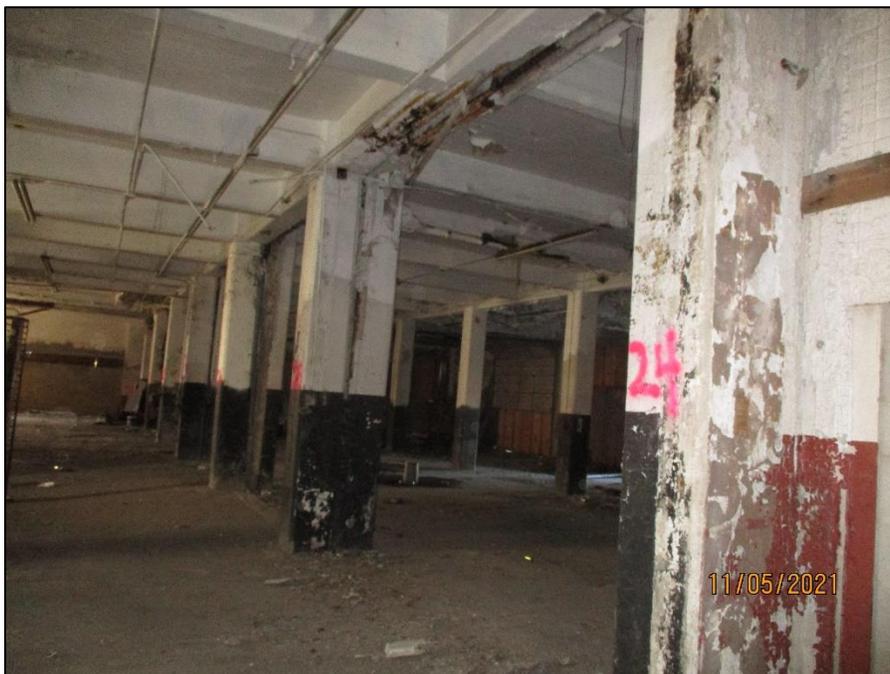
**Photograph 2**

Double columns along the center construction joint between the first addition (right) and the second addition (left).

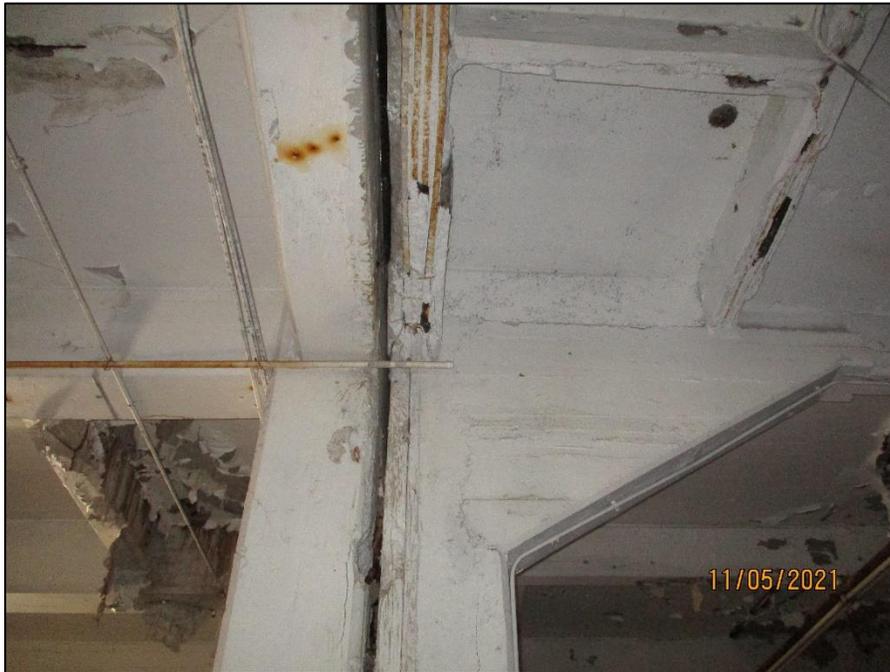
**Photograph 3**

Construction joint separation between the first addition (right) and the second addition (left) at the second floor.

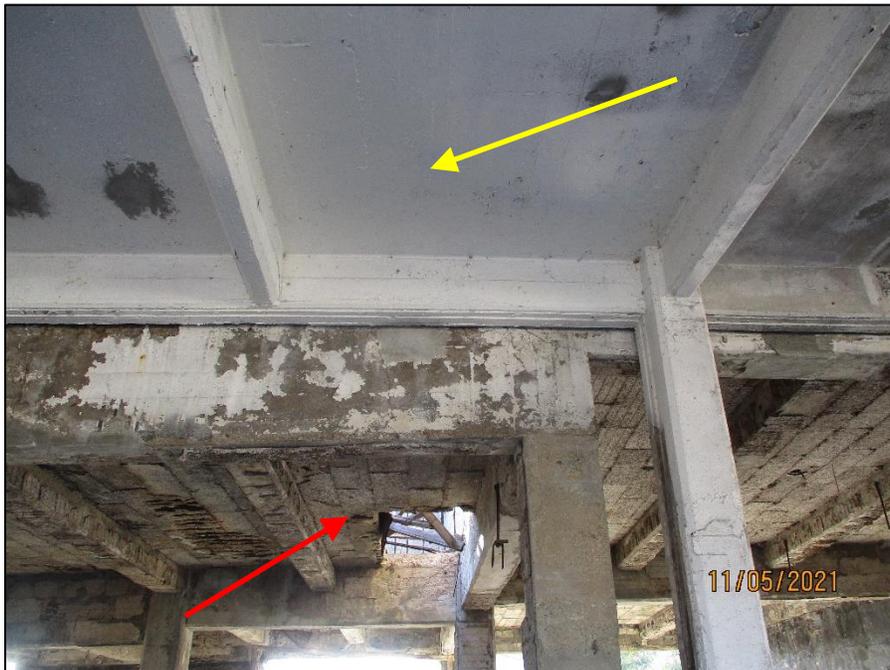
**Photograph 4**

- The second-addition concrete elements along the north exterior wall were deteriorated to a greater extent than concrete elements in the first addition. On the second addition, the concrete slabs, columns, and beams were cracked and spalled, exposing extensively corroded reinforcement. The corrosion had progressed through the full steel cross-section, breaking the reinforcement in multiple locations. Concrete elements in the first addition, while also spalled and cracked, remained substantially intact with less extensively corroded reinforcement (**Photograph 4**).

Typical conditions of the first concrete addition (yellow arrow) and the second concrete addition (red arrow).

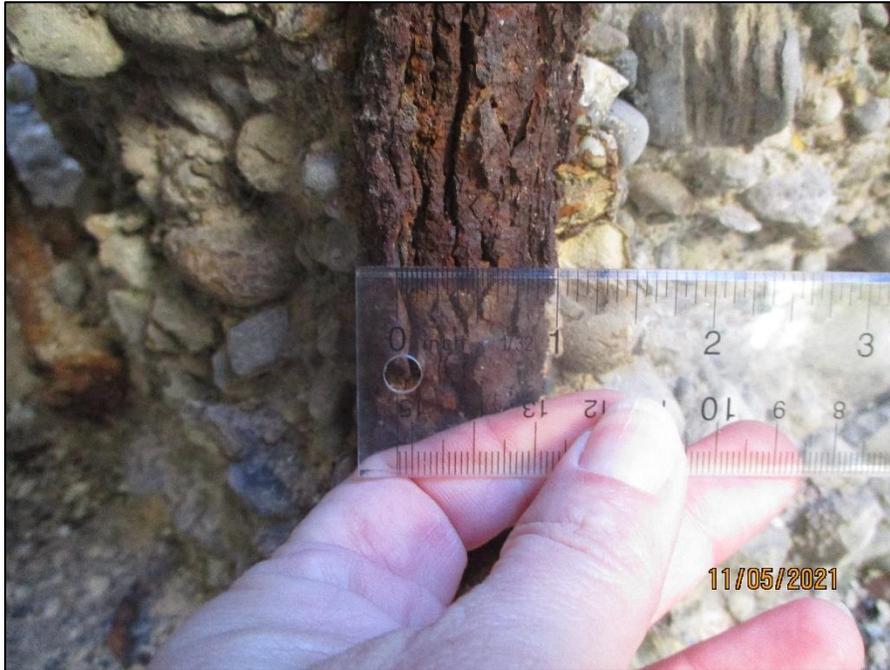
**Photograph 5**

- Where column reinforcement was exposed, the vertical reinforcement was severely corroded, and the remaining cross-sections were approximately 1 inch in diameter. In addition to the rust and surface delamination, longitudinal cracks had formed through the remaining cross-section (**Photograph 5**).

Typical vertical column reinforcement, corroded and with longitudinal cracks.

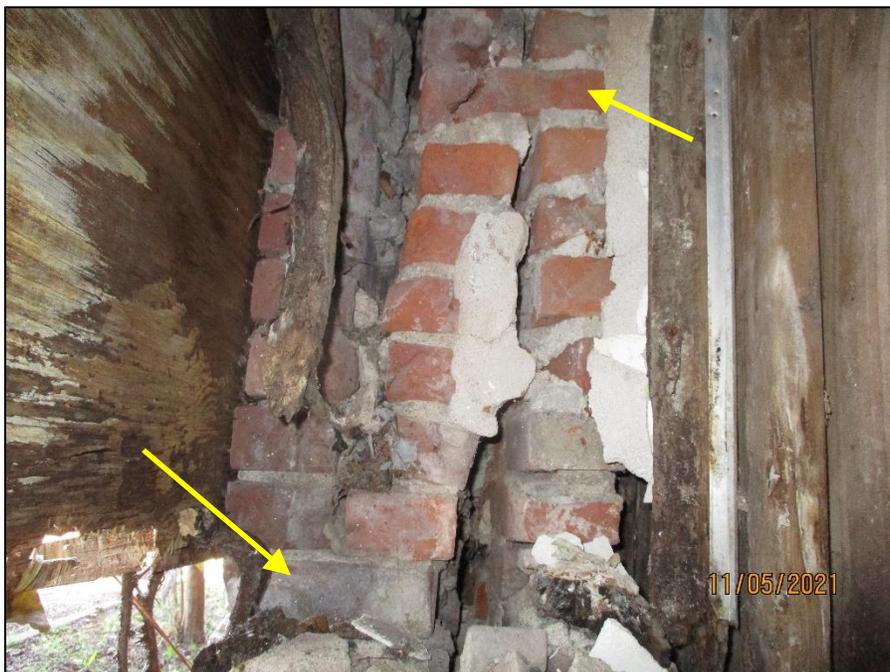
**Photograph 6**

Original structure: three-wythe exterior brick bearing wall with staggered header bricks (yellow arrows).

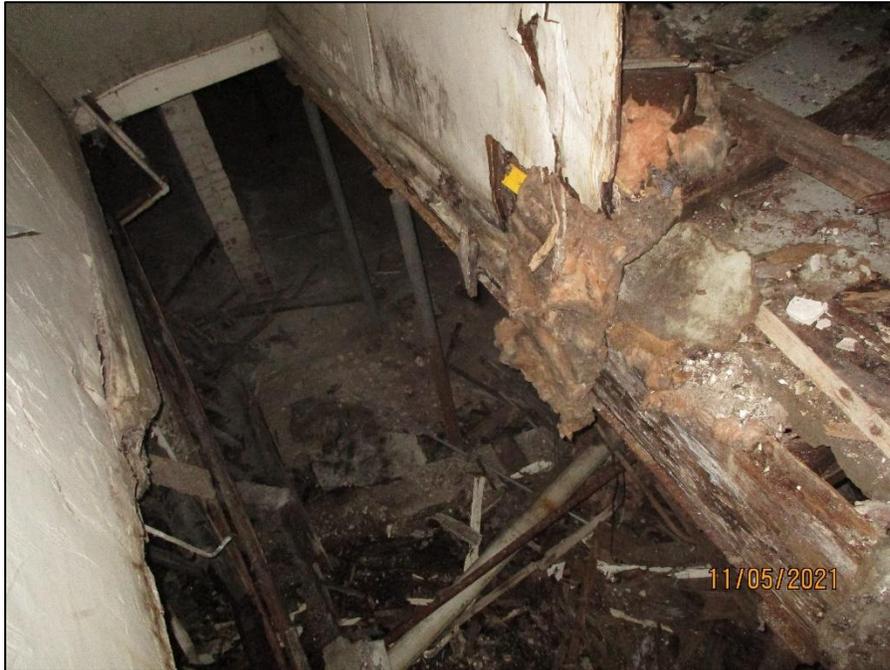
**Photograph 7**

The original structure has been categorized as **Unsafe**. At the time of Rimkus' inspection, the wood floor framing was rotted and had fallen in multiple locations. The deteriorated condition of the wood framing made the floors unsafe to walk on, and openings had been barricaded to restrict access to the interior.

Original structure: rotted and deteriorated wood floor framing leading into the basement.

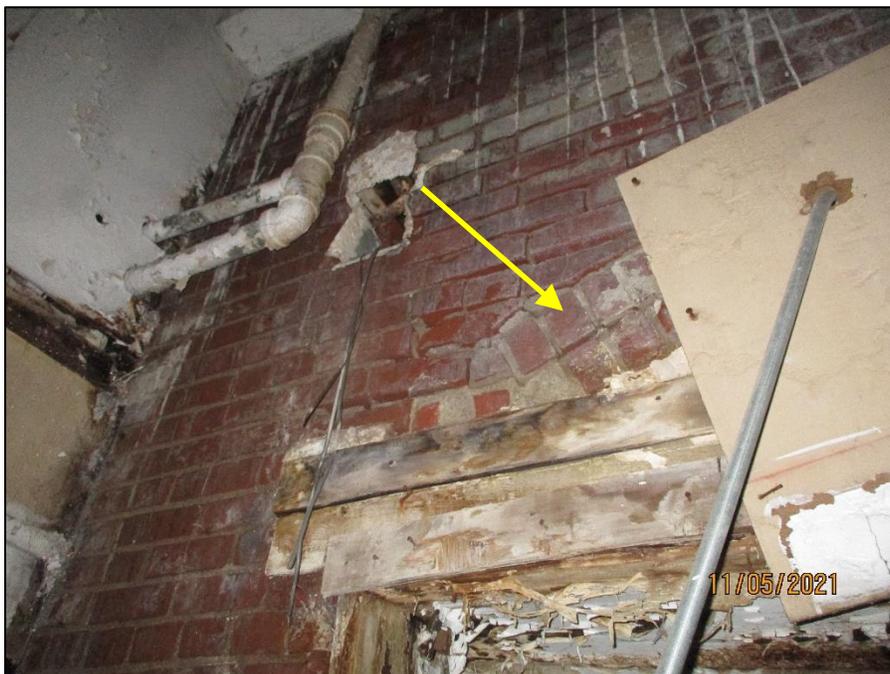
**Photograph 8**

Original structure: typical condition of the north and west brick walls. Note the structural brick arch over the opening.

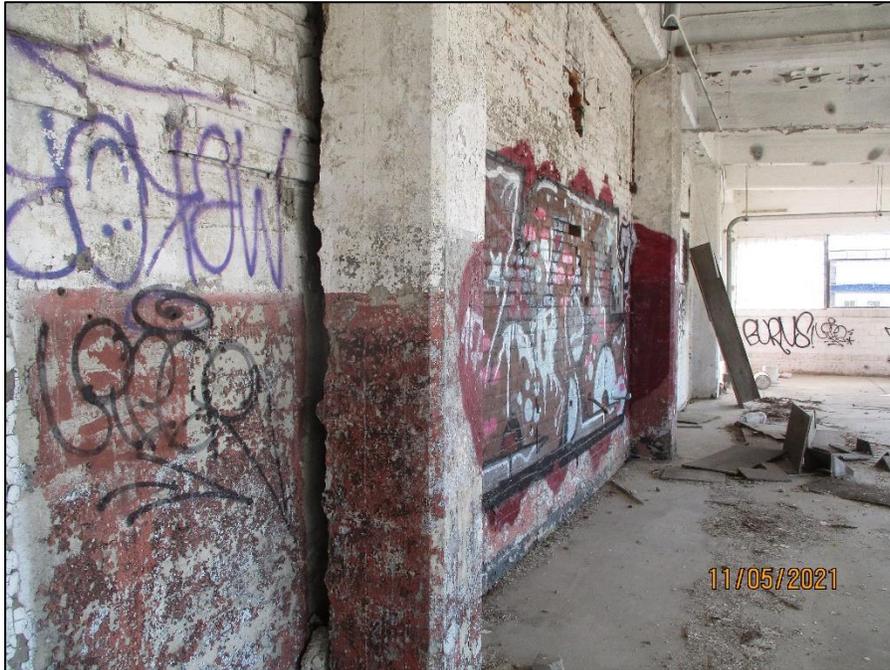
**Photograph 9**

- The roof and floors were framed with wood joists and wood plank decking laid perpendicular to the joists. The wood was darkened with moisture stains and had rotted in areas exposed to weather. The ground floor was supported by shoring poles and brick columns within the basement area (**Photograph 7**).
- The brick wall was exposed at the ground and second-floor openings through the north wall. At both levels, individual brick units were generally intact, but mortar pieces were missing along the joints (**Photograph 8**).
- On the second floor, the west wall of the original structure, multi-wythe brick, had separated from the second addition concrete columns (**Photograph 9**).

Original structure: west brick wall separated from the second addition concrete columns.

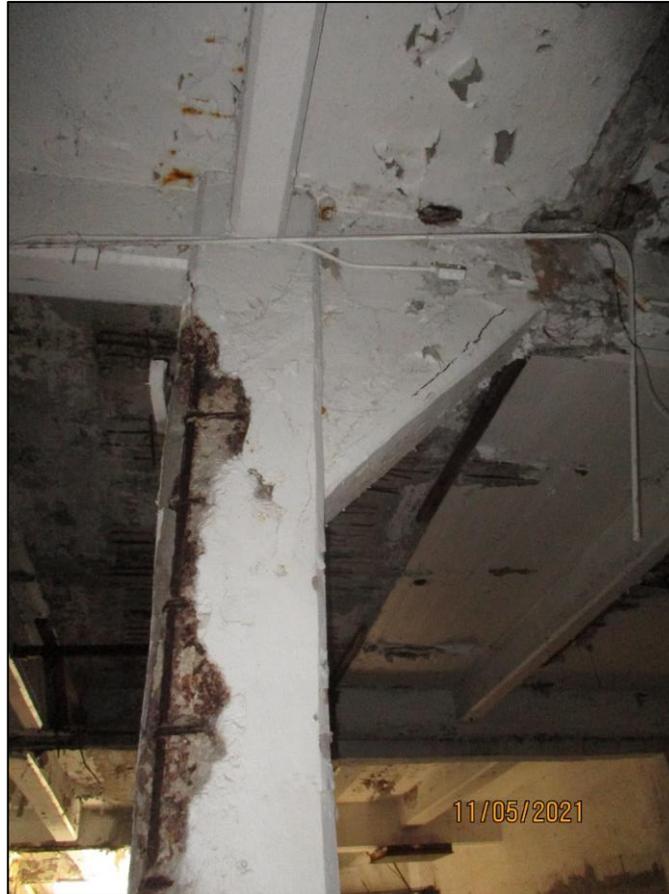
**Photograph 10**

First addition: exposed column ties and vertical steel.

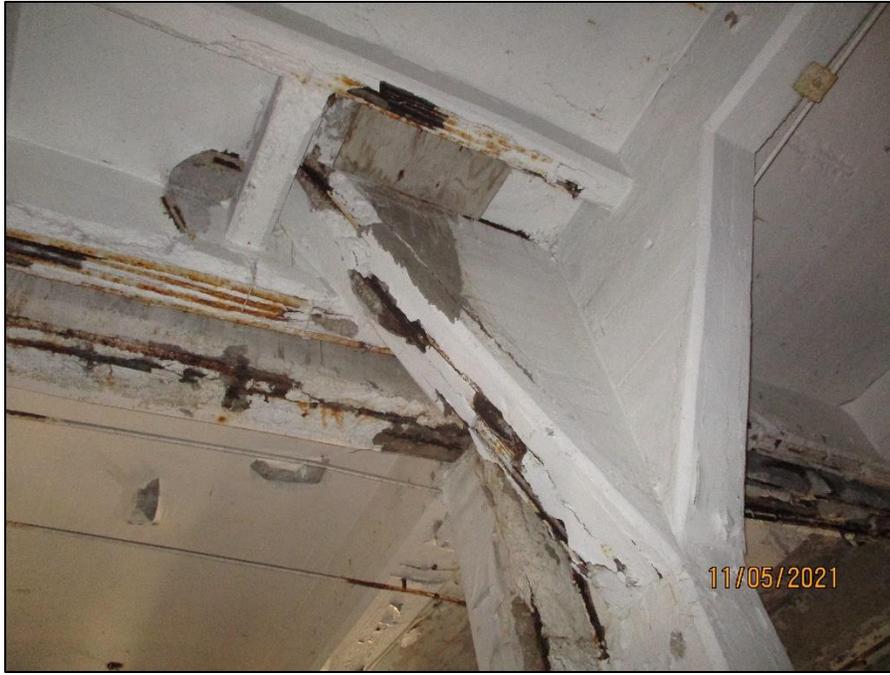
**Photograph 11**

- The bottom edges of the concrete haunches were cracked and spalled with corroded reinforcement. The remaining concrete areas of the triangular haunches were intact with limited cracking or spalling (**Photograph 11**).

The lateral capacity of the structure had been supplemented with the construction of triangular haunches at beam-to-column connections, which increased the inherent lateral stiffness of the structure. Although subject to the same spalled concrete and corroded reinforcement, the haunches remained substantially intact and continue to provide resistance against global structure movement.

First addition: concrete haunch at beam-to-column connections with spalled concrete along the bottom haunch edge.

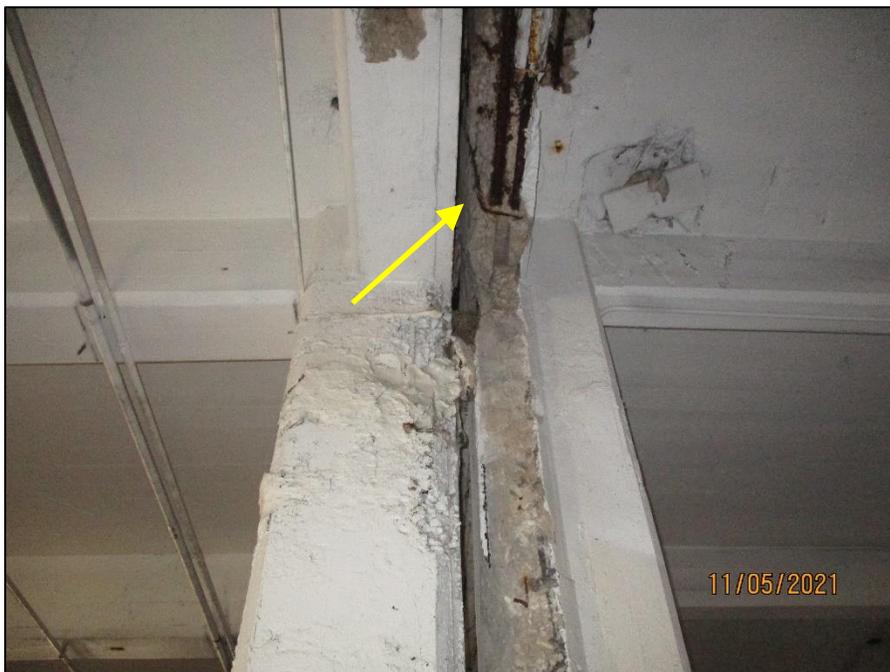
**Photograph 12**

First addition: beam ties and longitudinal reinforcement exposed by spalled concrete.

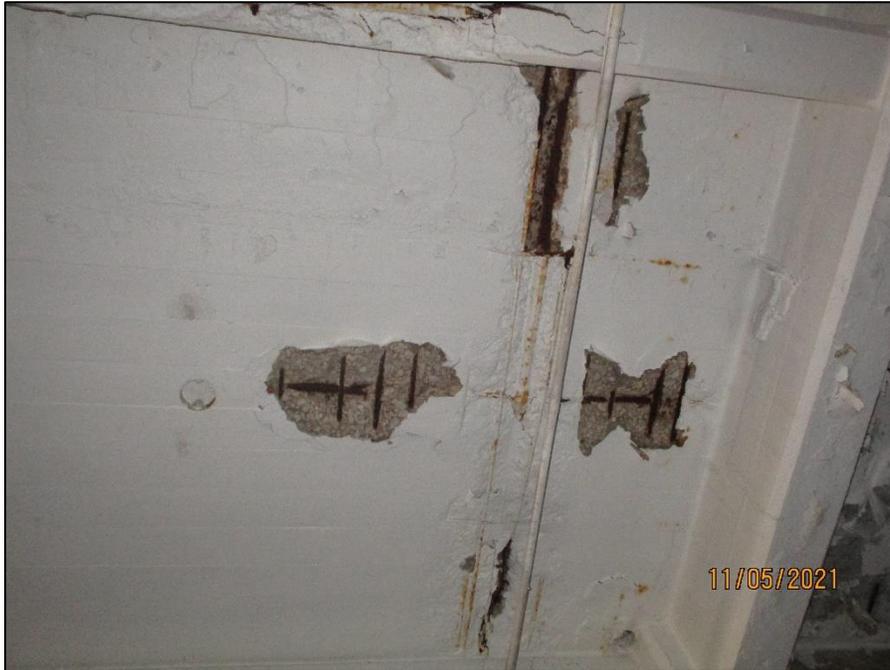
**Photograph 13**

First addition: second-floor slab reinforcement exposed by spalled concrete.

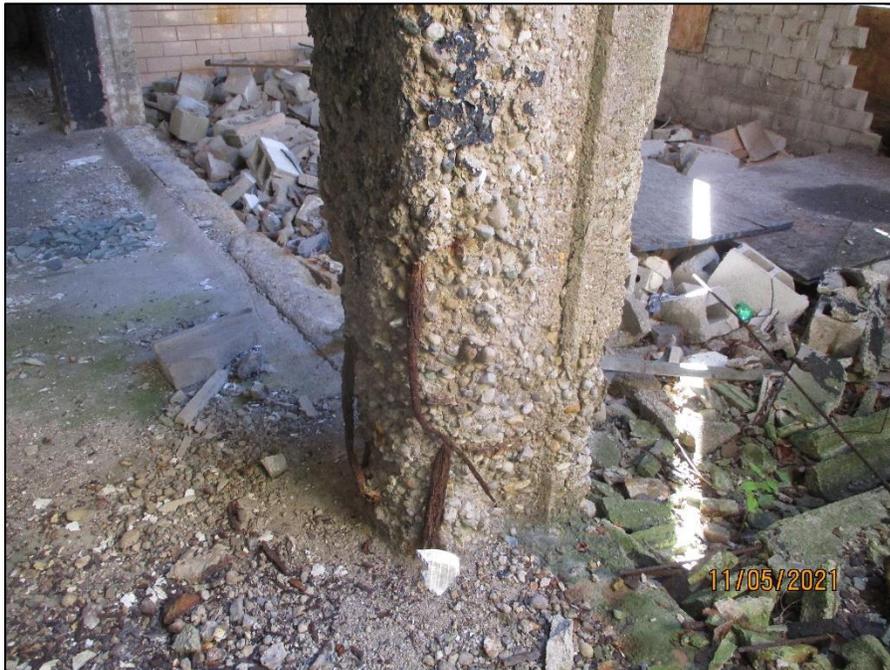
**Photograph 14**

Second addition: large, rounded river rock aggregate used in the concrete mix.

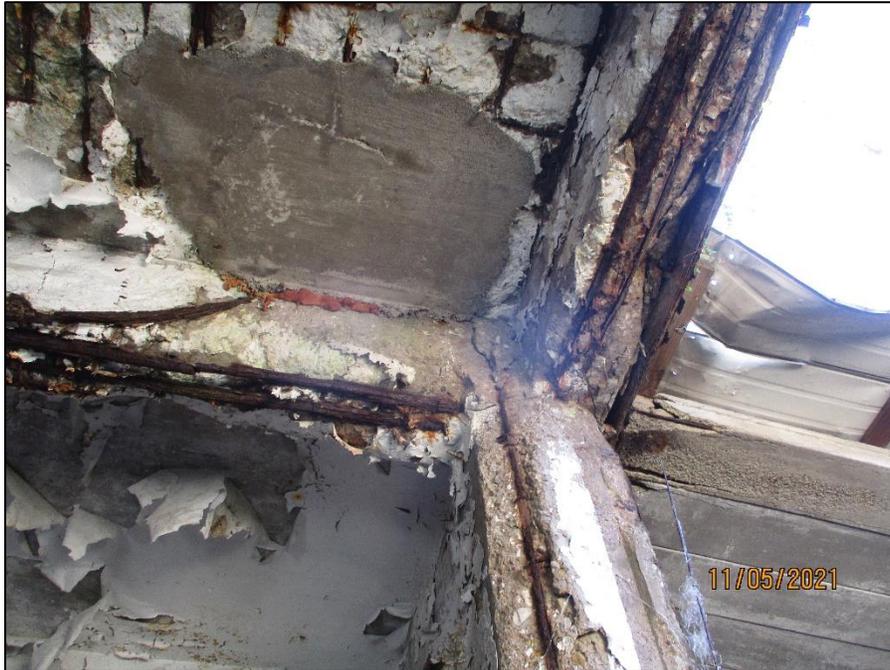
**Photograph 15**

- The northwest corner concrete elements were extensively spalled with corroded reinforcement (**Photograph 15**).
  - Concrete beams were constructed with four longitudinal bottom bars across the clear span. The outer two bars were bent-up bars at the beam-to-column connections. There were no ties or stirrups visible along any beams with exposed reinforcement.

Second addition: beam, column, and slab reinforcement exposed by spalled concrete.

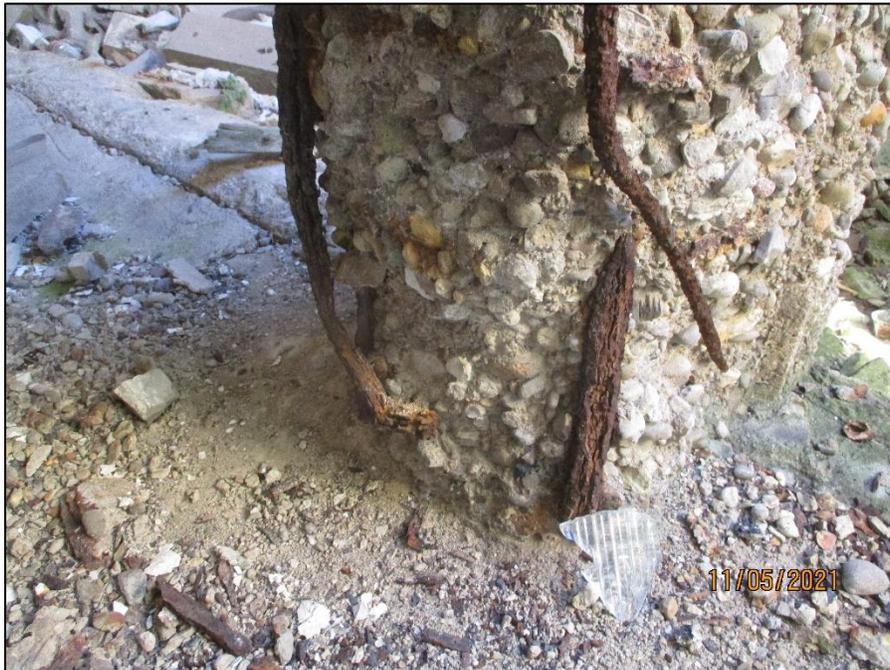
**Photograph 16**

- Concrete at the base of column 9 was severely spalled, reducing the column cross-section by an estimated 25 percent (%) and the vertical reinforcement broken (**Photograph 16**).

Second addition: vertical column reinforcement, corroded, and broken.

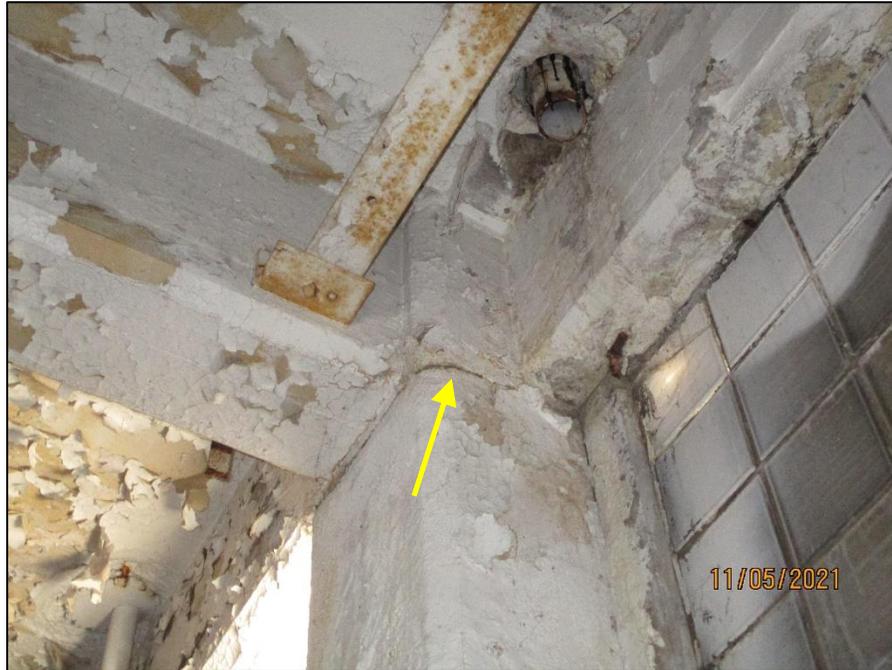
**Photograph 17**

- Concrete had cracked at beam-to-column connections around the column perimeter. This was a common condition, although not present at every column (**Photograph 17**).

connections have flexed under normal loads, as evidenced by the frequently cracked concrete around the columns at the bottom edge of the beams.

Second addition: concrete crack around the column at the base of the connecting beam.

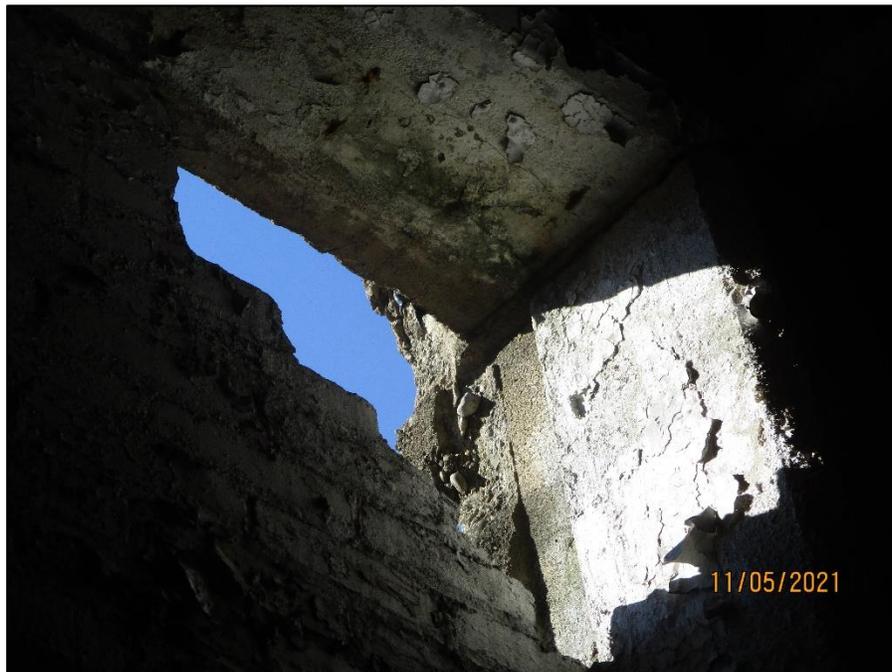
**Photograph 18**

Second addition: brick infill walls between columns but without a mechanical connection.

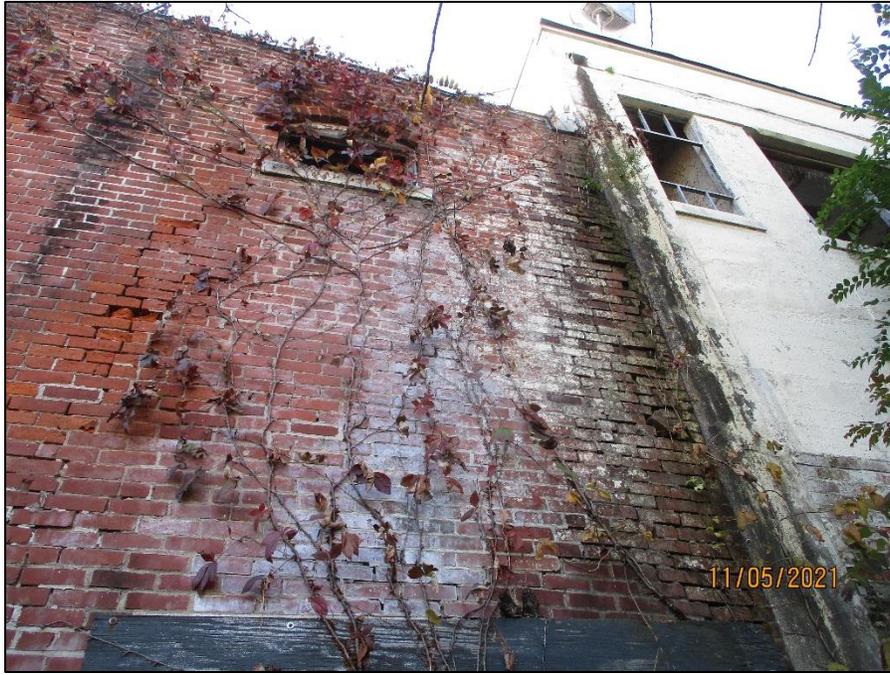
**Photograph 19**

- The east wall of the original structure, multi-wythe brick, was intact with minimal deterioration toward the south end (front). At the north end, the brick was darkened with water stains with vertical cracks extending from the top down to the finished grade. Additional deterioration at the north end included loose and displaced brick units and soft or missing brick mortar (**Photograph 19**).

Original structure: east exterior wall deteriorated at the joint with the first concrete addition.

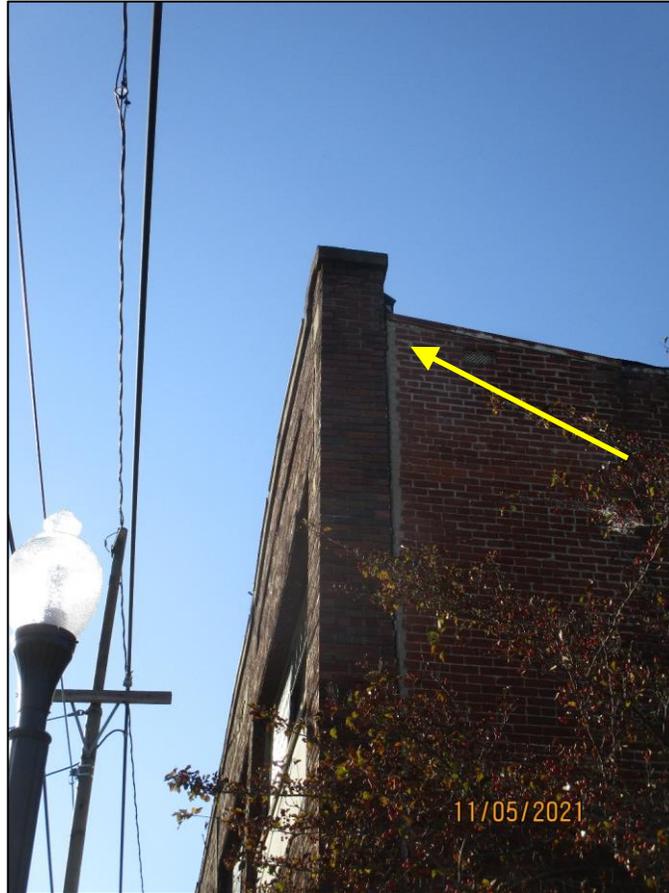
**Photograph 20**

- At the front façade:
  - The façade had separated from the east exterior wall at the top, leaving an estimated 2-inch-wide crack, narrowing toward the bottom of the wall (**Photograph 20**). The crack extended the full height of the joint and had been previously infilled with a repair mortar (**Photograph 21**).

Original structure: separation between the south exterior façade and the original structure, wide at the top and narrowed at the base.

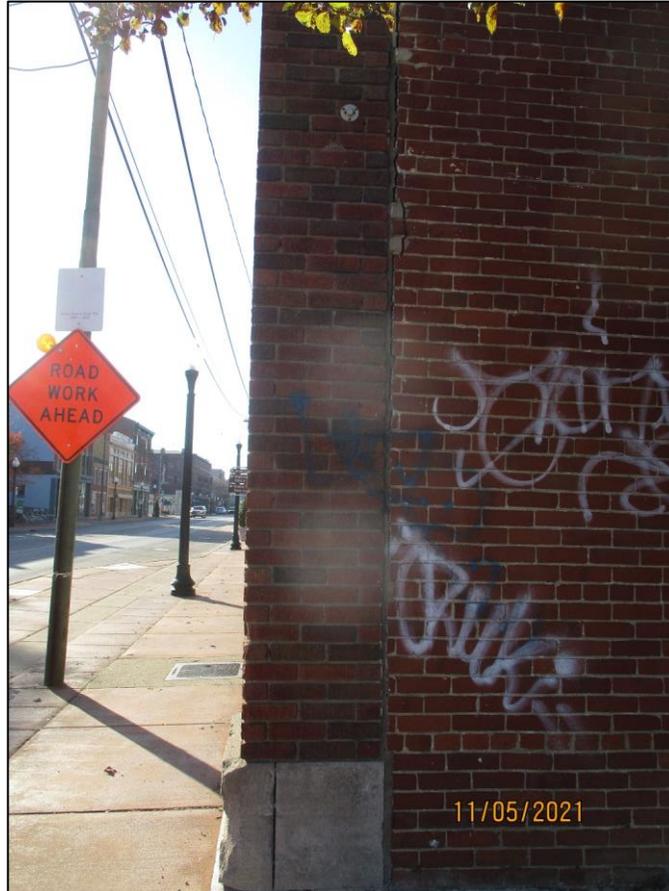
**Photograph 21**

Original structure: separation between the south exterior façade and the original structure, with new cracks through prior repairs.

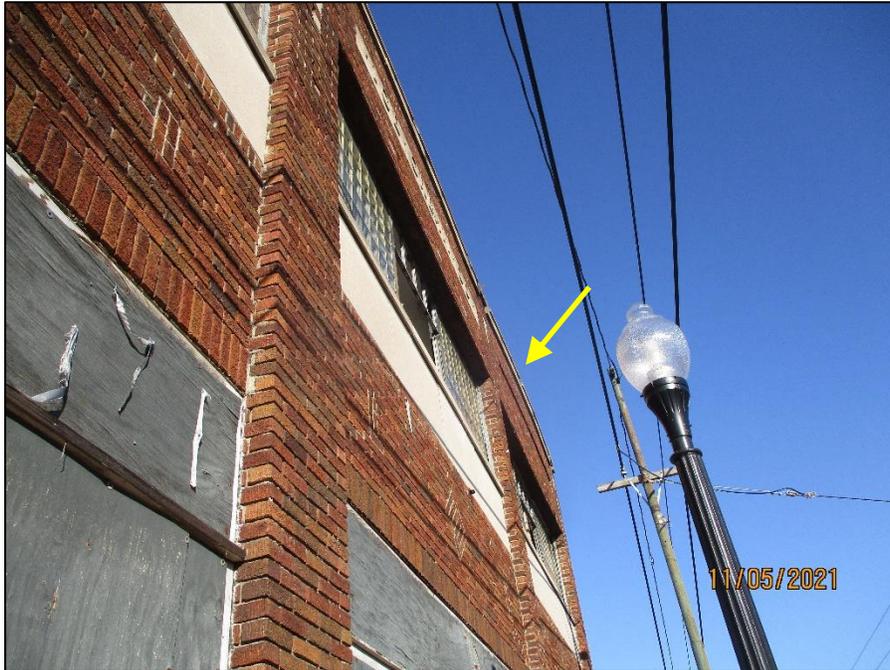
**Photograph 22**

Brick units in the façade were intact without displacement and minimal cracks or missing units. The mortar remained solid without loss of the cementitious binding and few open joints. Where the top of the parapet at the east end had rotated out of plane between the columns and away from the building, there was no damage within the façade itself that would indicate failure of the façade structure, indicating the movement was caused by global instability.

As previously described, floors and roof diaphragms provide out-of-plane bracing to brick walls, which prevents global rotation. Because the façade was constructed separately from the three buildings, it was not integrally connected with the floors or roof. As a result, although they provided support to the façade against movement toward the building interior, they provided little restraint against movement away from the building interior. As the wood framing deteriorated, the parapet rotation at the east end of the façade occurred and will continue to progress unless out-of-plane support is provided to the façade.

South exterior façade: top of parapet bowed out of plane.

- The south façade was constructed independently, after each of the three buildings was already present. With minimal damage to the brick and stone and notable out-of-plane movement limited to the parapet top, restoration of the south façade is well within a typical design and construction scope.

5. It is technically feasible to repair and stabilize the south exterior façade, with or without demolition of the three structures. Anchorage to the existing buildings once stabilized or installation of new support bracing if the buildings are demolished are both common practice and well within a typical design and construction scope.

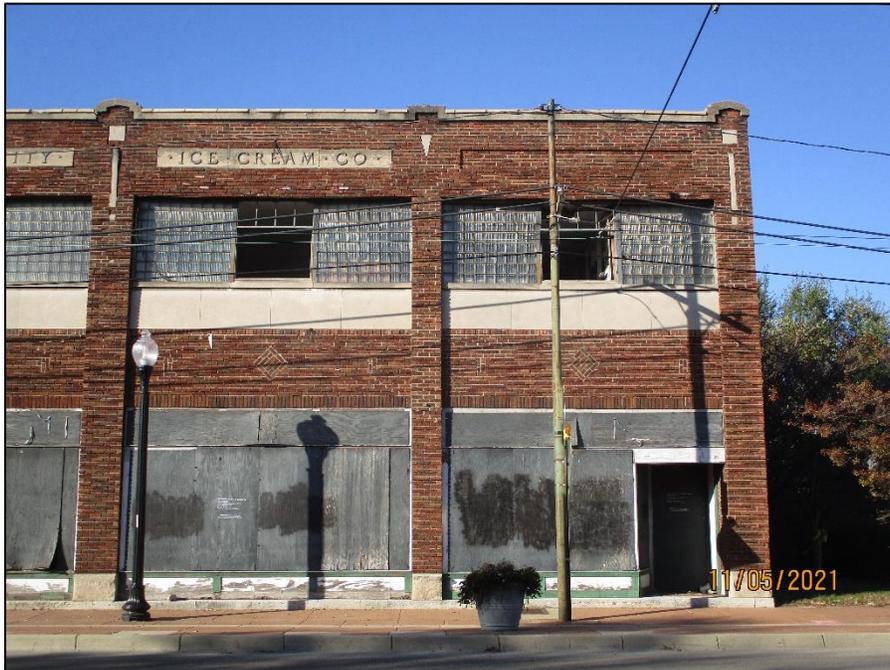
**Photograph 23**

- The remaining brick and stonework were generally intact and in-plane without visible displacement and minimal cracked, broken, or missing brick units (**Photograph 23**).

South exterior façade: typical brick and stone condition.

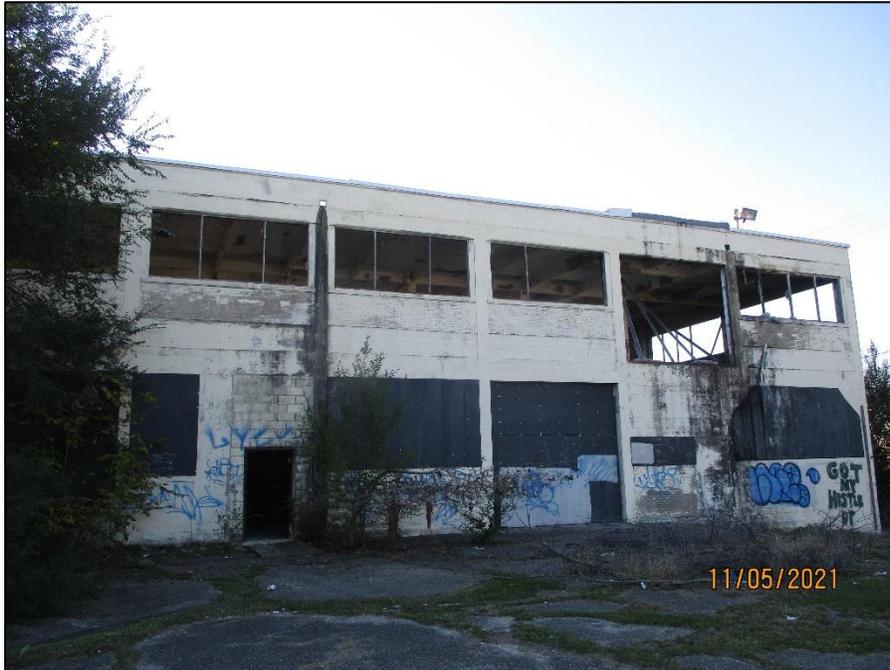
**Photograph 24**

- At the east exterior wall of the first addition (**Photograph 24**):
  - Concrete beams, columns, and slab edges were moderately deteriorated with concrete cracks visible from the ground.

- Cracks occurred primarily at joints between concrete and masonry infill and along the top of the second-floor windows where darkened water stains occurred.

First addition: overview of the east exterior wall.

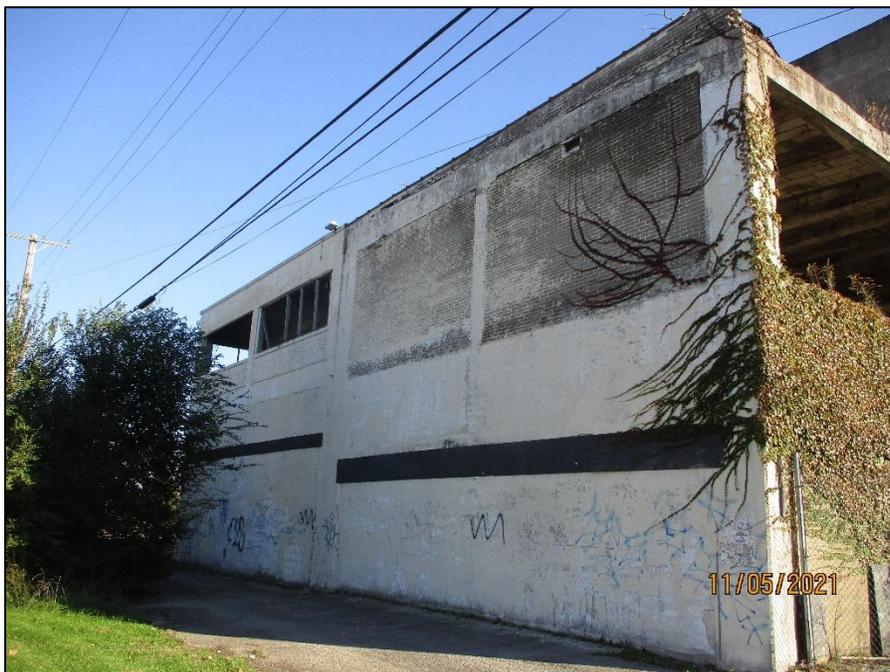
**Photograph 25**

- At the north exterior wall (**Photograph 25**):
  - Concrete beams, columns, and slab edges visible on the north exterior wall were moderately deteriorated with concrete cracks visible from the ground.
  - On the north wall, stairstep cracks were present in the concrete masonry unit (CMU) infill at the ground level. The cracks stopped at the concrete to CMU joints.

Overview of the north exterior wall, including the first addition (left) and second addition (right).

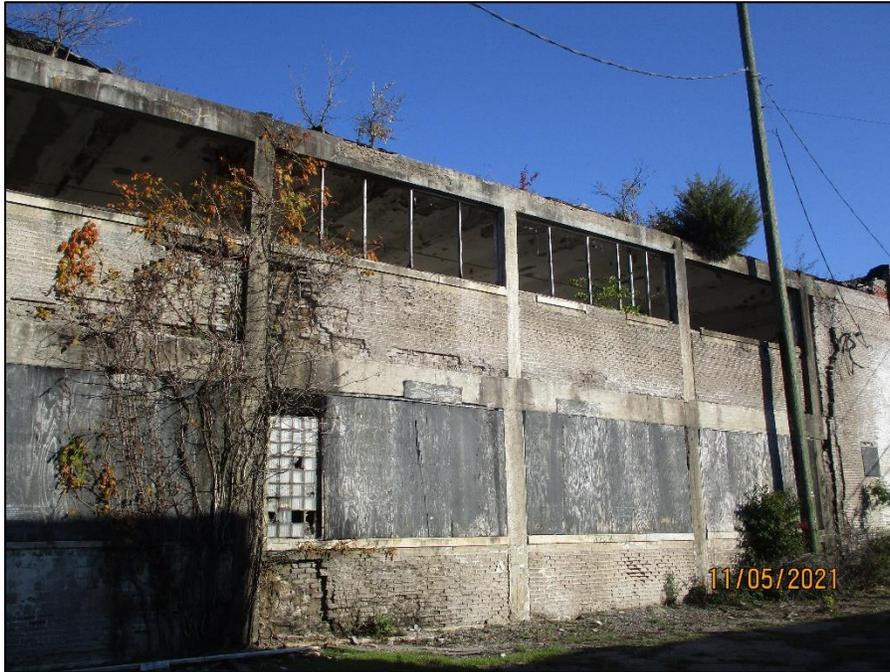
**Photograph 26**

- At the east exterior wall (**Photograph 26**):
  - Concrete had spalled from the exposed beam and slab edges and cracks extended through columns. Infill walls between concrete columns were constructed from a combination of CMU, concrete brick, and clay brick, and individual masonry units were broken, cracked, or missing.
  - The north penthouse was cast concrete with vertical cracks along the full height of the walls. The cracks extended through the supporting roof concrete beam and progressed through the roof slab toward the building interior (**Photograph 27**).
  - The middle penthouse was constructed using clay CMU with an exterior cementitious finish. Clay unit corners were broken, and mortar was missing along the joints (**Photograph 28**).

Second addition: Overview of the west exterior wall.

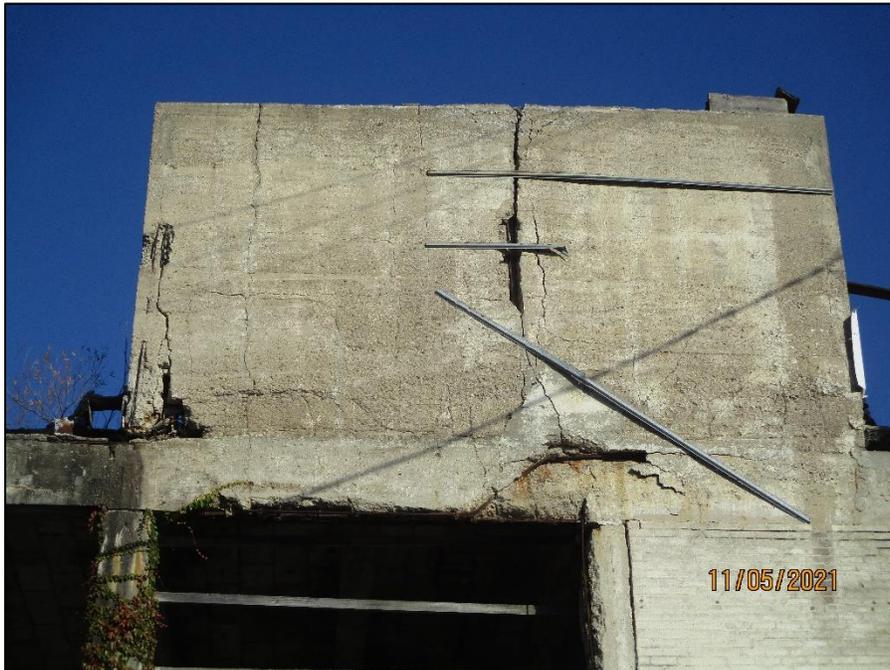
**Photograph 27**

Second addition: North penthouse with concrete cracks.

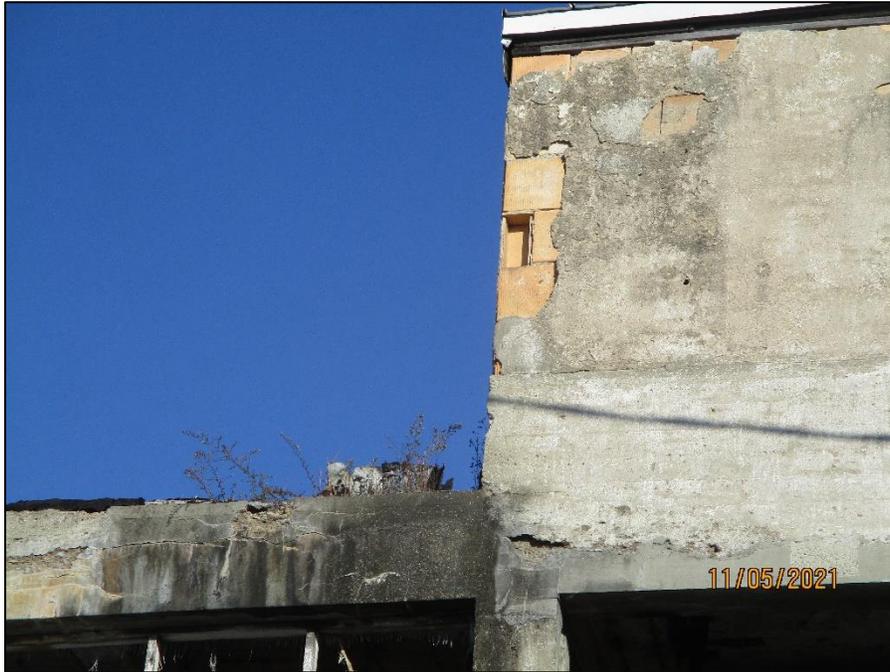
**Photograph 28**

Second addition: middle penthouse constructed with clay CMU.
